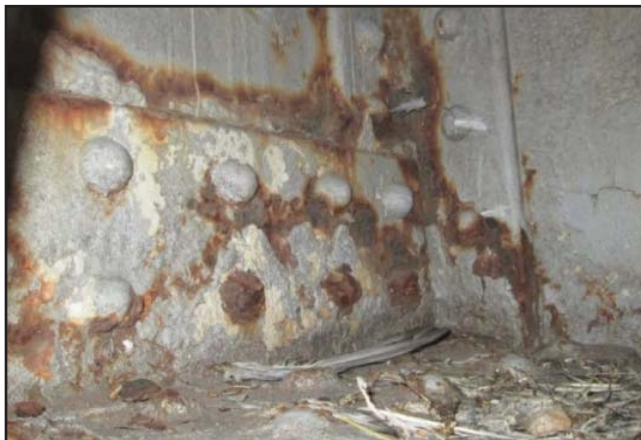
**Middle Left**

- **Trussed-Arch Spans** — Significant deterioration of structural steel has occurred at truss elements, gusset plates, connectors, bearings and steel stringers that support the roadway. Corrosion and deterioration are most prominent near roadway expansion joints where supporting elements are exposed to roadway drainage, but also occur throughout. Many of these elements need to be repaired or replaced. In addition, fatigue retrofits, painting and repairs to hanger assemblies are needed to prolong the life of the existing structure. Likewise, condition of the roadway deck and expansion joints warrant replacement of these items.

Typical deterioration at steel elements

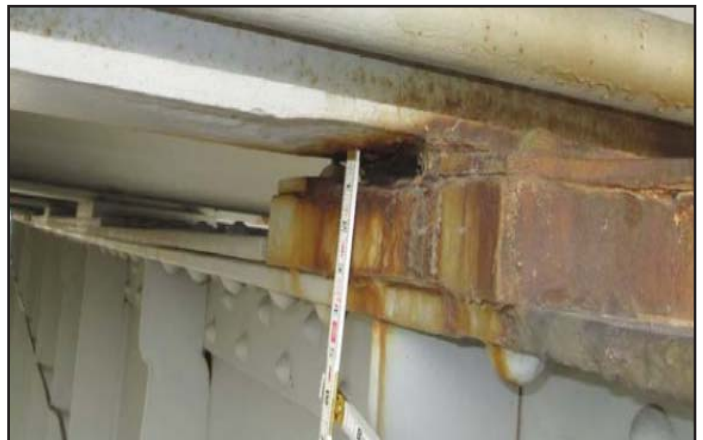
**Middle Right**

- **Structural Steel** — The sections with the most severe bridge deterioration occur at stringer ends of the main spans, keeper plates, and floorbeam webs. Ends of steel stringers that support the roadway deck are exhibiting serious deterioration and section loss due to long-term exposure to chloride contaminated runoff from the deck through open joints and curbs. Cracking also occurs in the stringer webs. The stringers are supported on steel plate bearings which are also deteriorating with extensive pack rust between the steel plate bearings and bottom flange of the stringers. Section loss occurs in top and bottom flanges of the floorbeams. Pitting in the floorbeam webs occurs throughout. Pack rust occurs between stiffening angles and floorbeam webs, with holes occurring in the floorbeam stiffening angles. Tie girders at the arch spans have pack rust between top plates and connecting angles which causes cupping and bowing of the top plates. Localized areas of pitting also occur on the tie girders. Portal frames, box members and gusset plates all have pack rust between plies of steel and deterioration.

Pack rust at stringer bearing plates

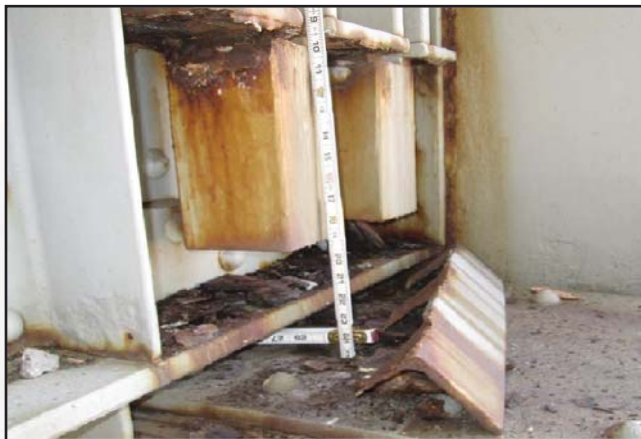
**Bottom Left**

- **Suspender Cable Keepers** — At each of the cable supports on the mains spans the lower sockets of the cables are retained by keeper angles. These angles were attached with tap bolts to the socket bearing plate. Pack rust has formed between the keeper angles and the bearing plates at most locations. The pack rust is prying the keeper angles away from the bearing plate, and in some instances the bolts have failed and the keeper angles are no longer in place.

Broken retainer angle at suspender cable socket

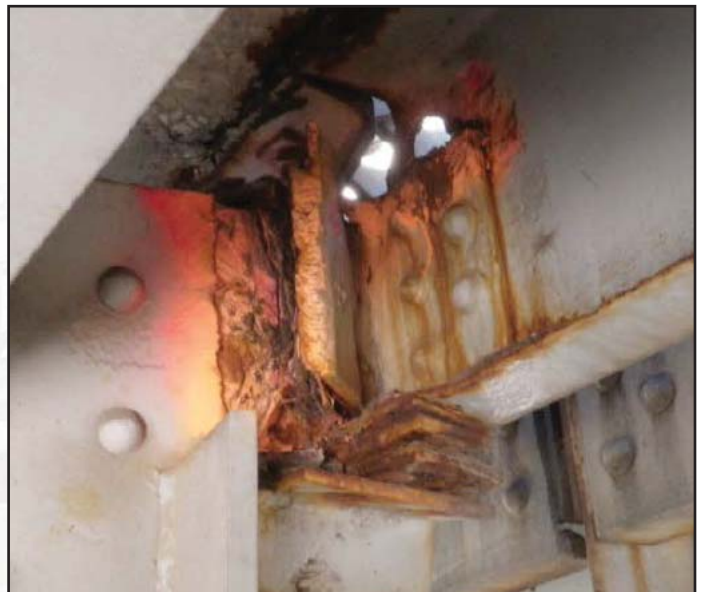
**Bottom Right**

- **Expansion Joints** — The finger plate expansion joints at each end of the main spans have no drainage collection system. This allows roadway drainage to flow onto underlying structural steel and pier tops. Although vertical misalignment has occurred at the joints, the finger plates are in satisfactory condition, but the supporting steel structure below is deteriorating. Pack rust, deterioration and broken clip angles occur at the joint support brackets. Compression seal joints at contraction joint locations have failed in all main spans. Filler material in the compression seals is missing and armoring is missing or damaged, again allowing roadway drainage access to structural steel elements below.

Deterioration at expansion joint support

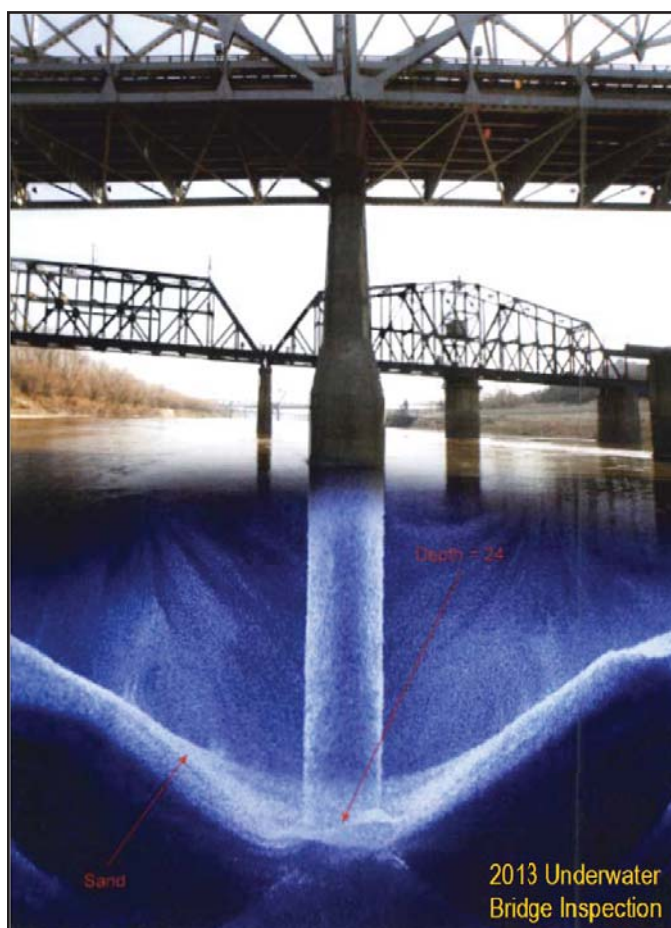
- **Main Span Piers and Scour** — A significant scour hole up to 24 feet deep is present at Pier 2. Pier 2 is located near the middle of the river at the north end of the 540-foot navigation span. The scour occurs on all sides of the pier. The pier is embedded approximately 1 foot into shale. Faces of the piers are in generally poor conditions. Areas of delamination and spalls occur on the faces and corners. Elevated chloride content occurs in the concrete.

*Top Left*  
Underwater sonar investigations have identified a significant scour hole at Pier 2

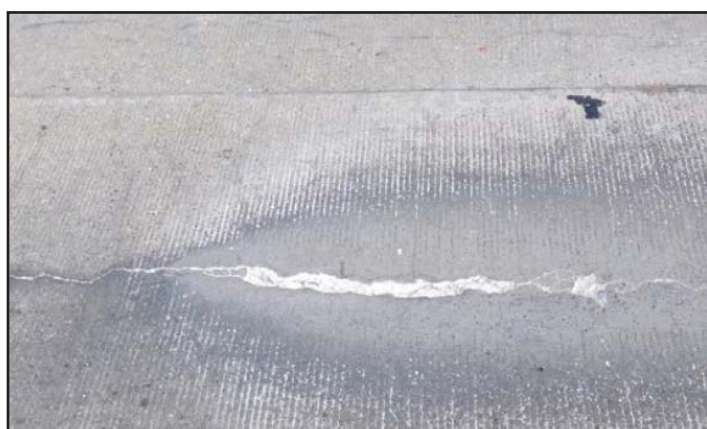
- **Bridge Deck** — The existing bridge deck has a low slump overlay on top which has numerous cracks in both the transverse and longitudinal directions, and deterioration near drain locations. Stay-in-place forms underneath the deck exhibit bulging in some places. The overlay above and deck forms underneath hinder crack detection in the actual deck. Based on reported visual observations, it is estimated that half-sole repairs are required on 20%, and full depth repairs are required on 15% of the deck area. Deck saturation also occurs in the north approach spans.

*Top Right*  
Deck cracking in overlay

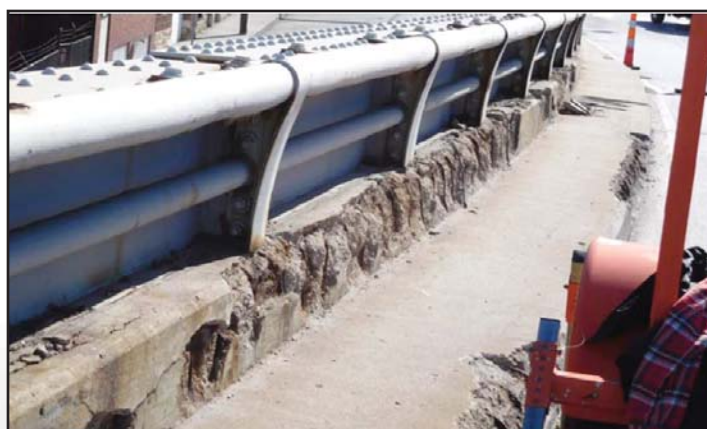
*Middle Right*  
Concrete spalling along the shoulders

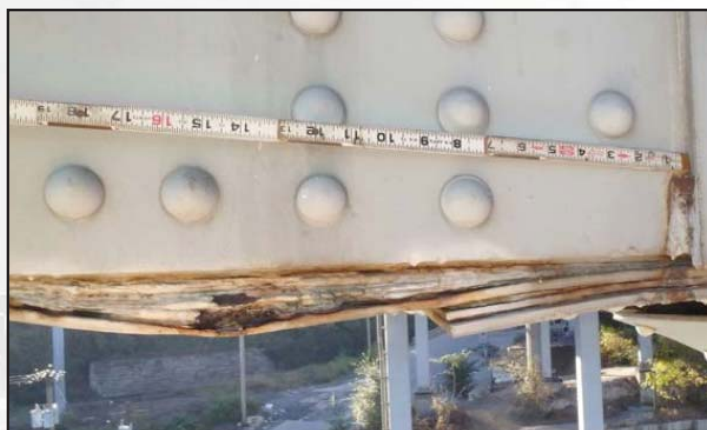
- **Approach Span Piers** — Pack rust occurs between flanges and connecting angles, and end plates and connecting angles at the approach piers. Localized concrete spalling also occurs.

*Bottom Right*  
Extensive corrosion at the approach piers

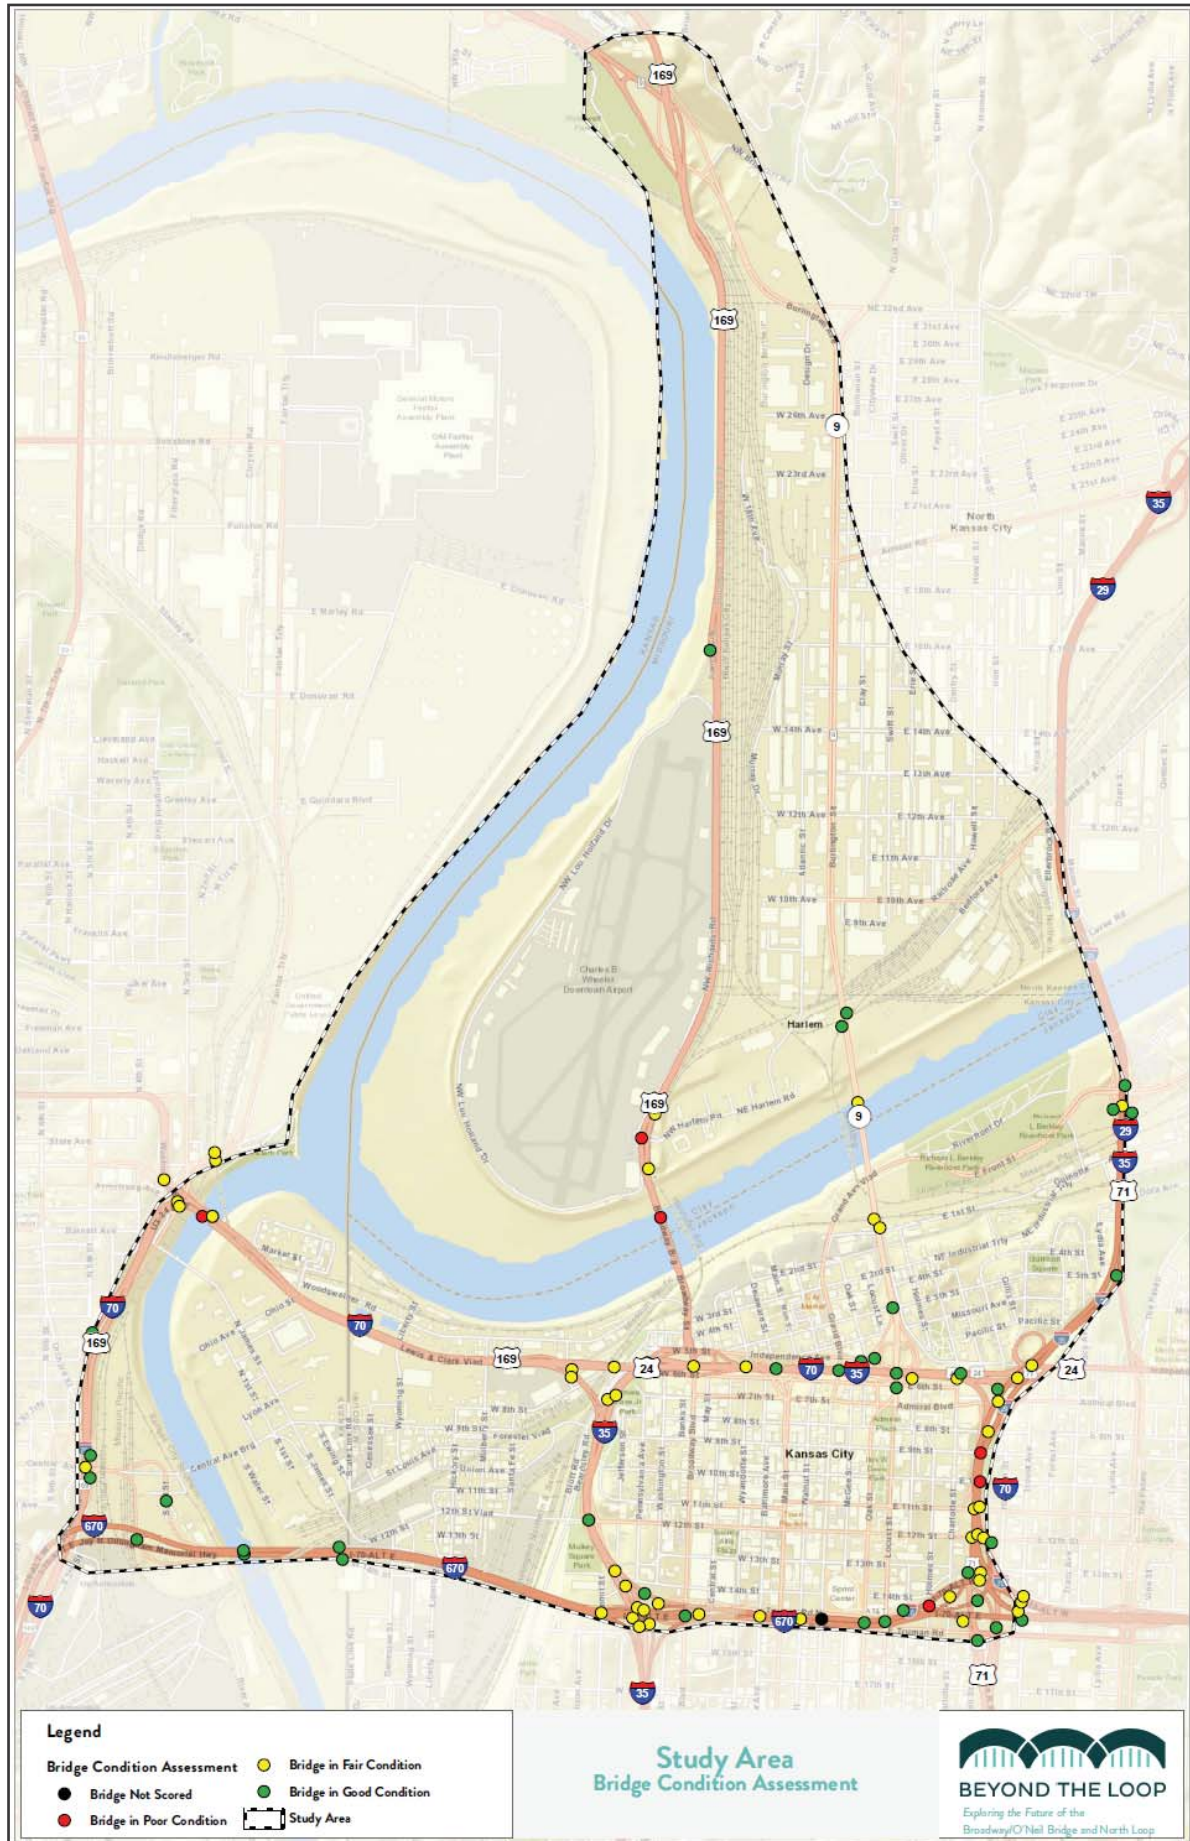
Figure 2.1 - Existing Bridge Condition Ratings

Figure 2.1 shows current NBIS ratings for all bridges in the Study Area. Six structures have one or more ratings of 4 or less and are indicated as poor. Bridge B0031 carrying I-70 over the Kansas River is in the final states of plan development and KDOT received construction bids in November 2017.

*Six bridges in the Study Area, including the Buck O'Neil Bridge are considered in poor condition.*

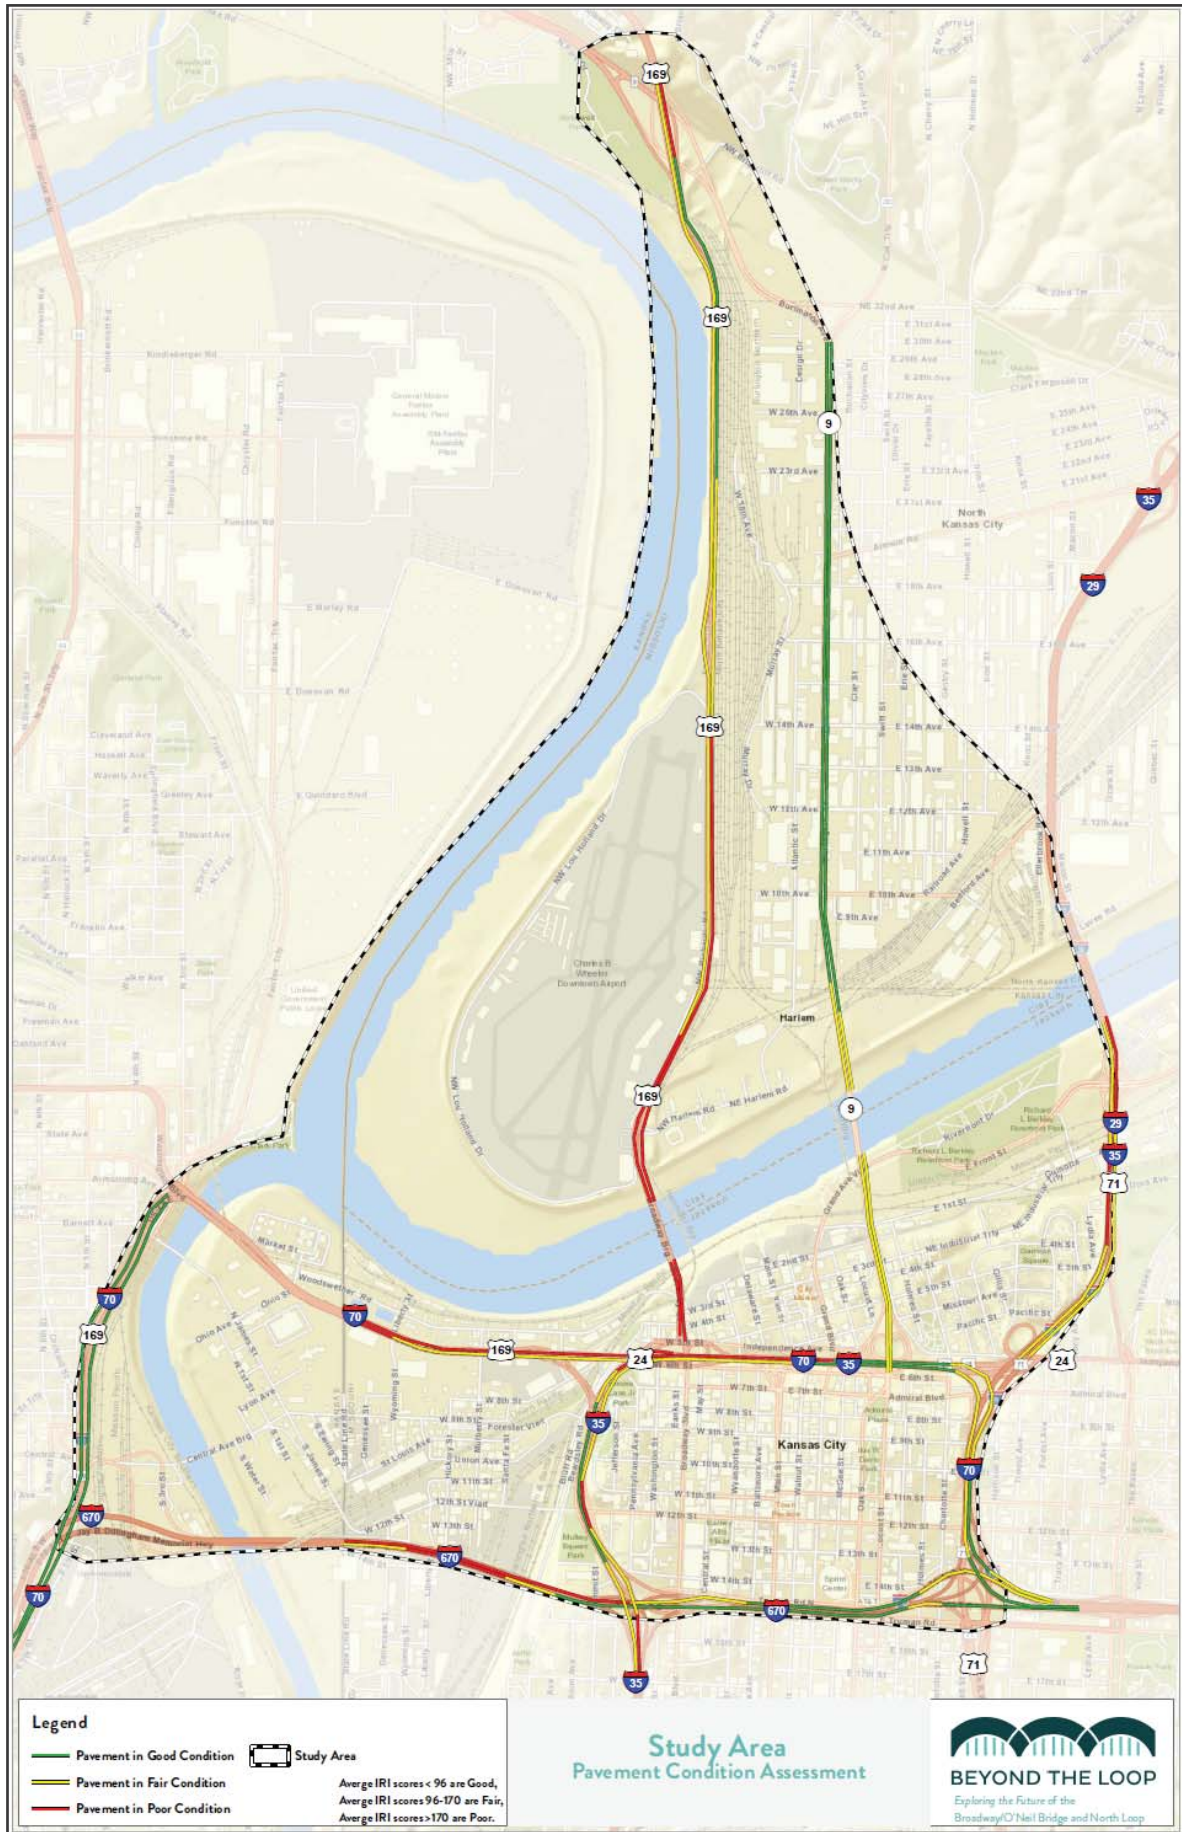
Figure 2.2 -Existing Pavement Conditions

Several segments of highway in the Study Area have roadway pavement conditions considered “poor.” Figure 2.2 identifies those areas in red and includes most of US-169, most of the I-70 Loop, and sections of I-670.
