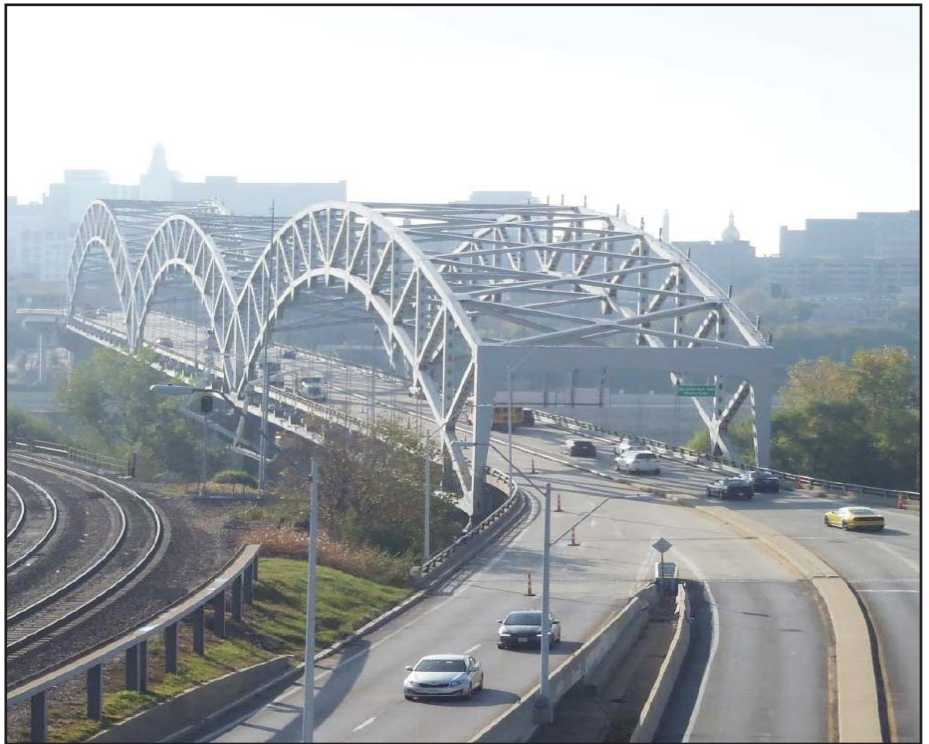
- **Trussed-Arch Spans** — Significant deterioration of structural steel has occurred at truss elements, gusset plates, connectors, bearings and steel stringers that support the roadway. Corrosion and deterioration are most prominent near roadway expansion joints where supporting elements are exposed to roadway drainage, but also occur throughout. Many of these elements need to be repaired or replaced. In addition, fatigue retrofits, painting and repairs to hanger assemblies are needed to prolong the life of the existing structure. Likewise, condition of the roadway deck and expansion joints warrant replacement of these items.

- **Structural Steel** — The sections with the most severe bridge deterioration occur at stringer ends of the main spans, keeper plates, and floorbeam webs. Ends of steel stringers that support the roadway deck are exhibiting serious deterioration and section loss due to long-term exposure to chloride contaminated runoff from the deck through open joints and curbs. Cracking also occurs in the stringer webs. The stringers are supported on steel plate bearings which are also deteriorating with extensive pack rust between the steel plate bearings and bottom flange of the stringers. Section loss occurs in top and bottom flanges of the floorbeams. Pitting in the floorbeam webs occurs throughout. Pack rust occurs between stiffening angles and floorbeam webs, with holes occurring in the floorbeam stiffening angles. Tie girders at the arch spans have pack rust between top plates and connecting angles which causes cupping and bowing of the top plates. Localized areas of pitting also occur on the tie girders. Portal frames, box members and gusset plates all have pack rust between plies of steel and deterioration.

- **Suspender Cable Keepers** — At each of the cable supports on the mains spans the lower sockets of the cables are retained by keeper angles. These angles were attached with tap bolts to the socket bearing plate. Pack rust has formed between the keeper angles and the bearing plates at most locations. The pack rust is prying the keeper angles away from the bearing plate, and in some instances the bolts have failed and the keeper angles are no longer in place.

- **Expansion Joints** — The finger plate expansion joints at each end of the main spans have no drainage collection system. This allows roadway drainage to flow onto underlying structural steel and pier tops. Although vertical misalignment has occurred at the joints, the finger plates are in satisfactory condition, but the supporting steel structure below is deteriorating. Pack rust, deterioration and broken clip angles occur at the joint support brackets. Compression seal joints at contraction joint locations have failed in all main spans. Filler material in the compression seals is missing and armoring is missing or damaged, again allowing roadway drainage access to structural steel elements below.

Buck O'Neil Bridge is a trussed-arch bridge that carries four lanes of traffic over the Missouri River, Union Pacific Railway, BNSF Railroad, 3rd Street, 4th Street, Woodswether Road and Richards Road

Typical deterioration at steel elements

Pack rust at stringer bearing plates

Broken retainer angle at suspender cable socket

Deterioration at expansion joint support

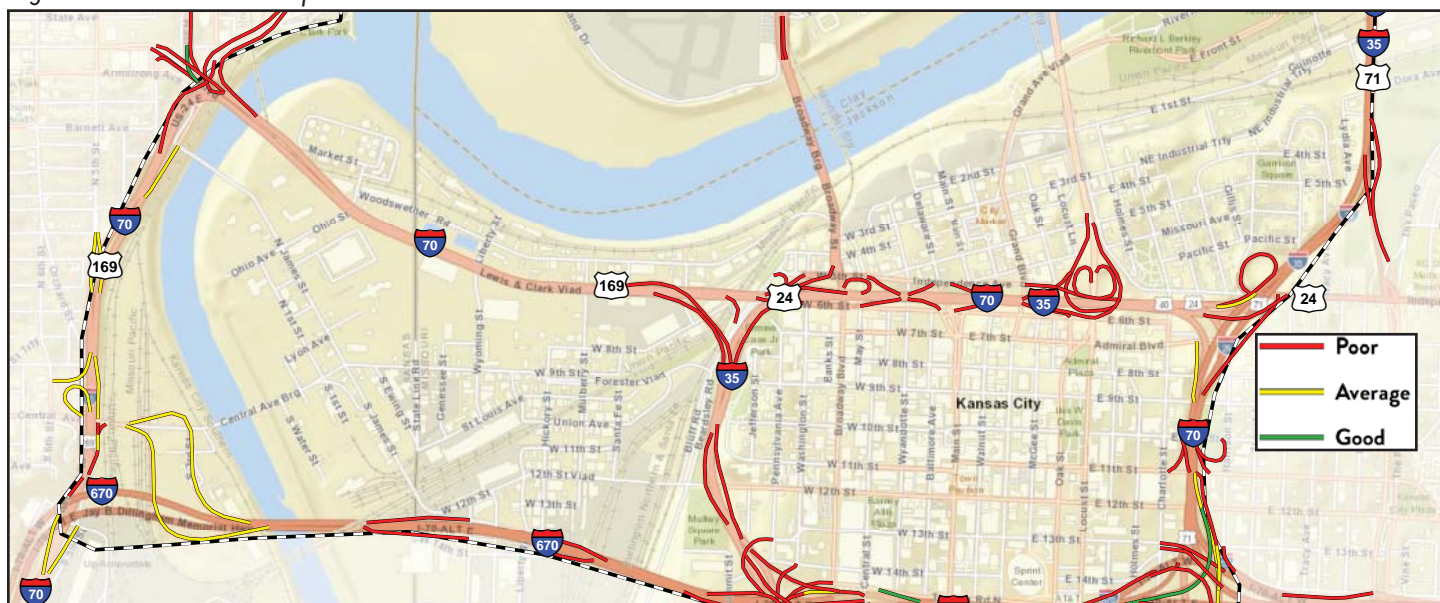
Figure 2.5 - Outside Ramp Shoulder Widths

- **Ramp Shoulder Widths** — The existing shoulder width on most of the ramps is less than the current AASHTO design guideline recommends. Figure 2.5 illustrates the outside shoulder width for ramps in the Study Area compared to the desired design. Figure 2.6 notes the inside shoulder width for ramps.

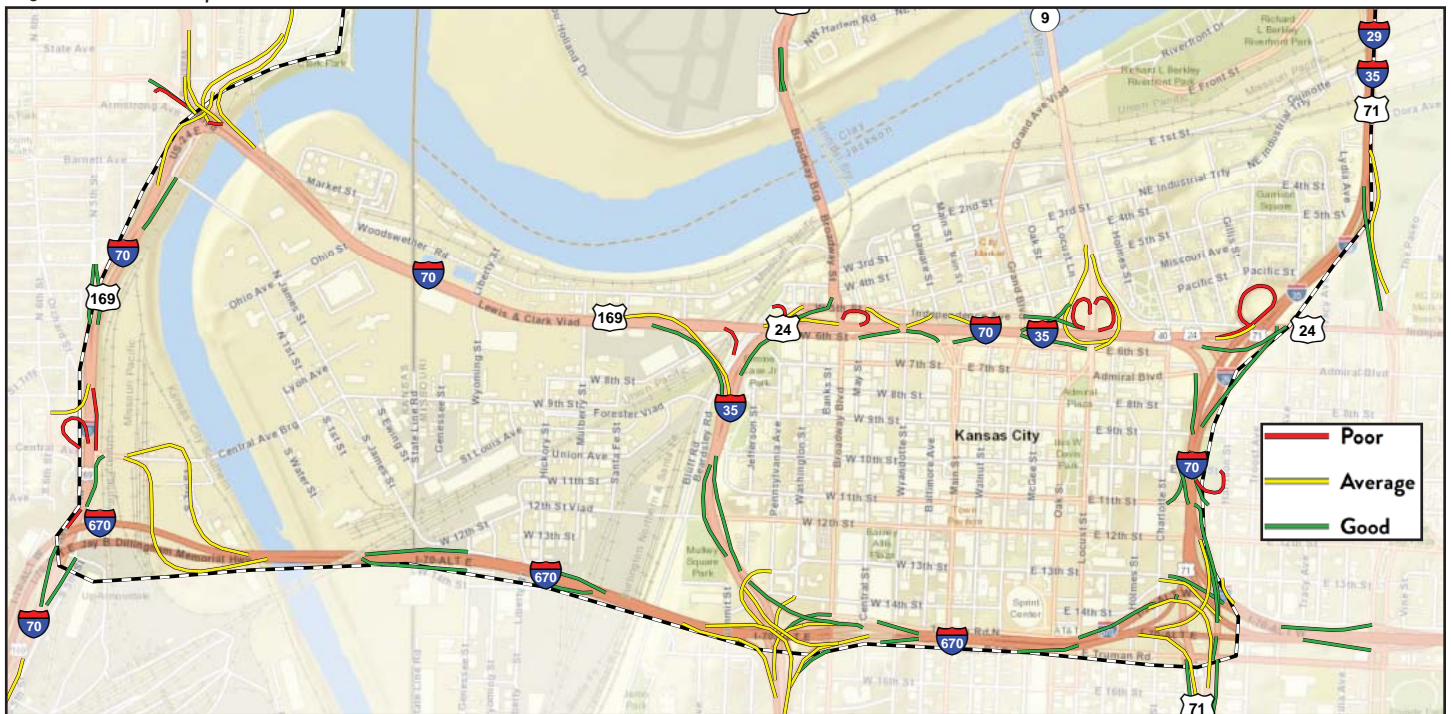
Figure 2.7 - Ramp Radii

- **Ramp Curvature** — Many of the existing ramps have a horizontal curvature below the current design guideline. The horizontal curvature was rated as meeting the current design guideline, nearly meeting the guideline, and below current design guidance. Figure 2.7 illustrates the ramps in the Study Area and an assessment of horizontal curvature.

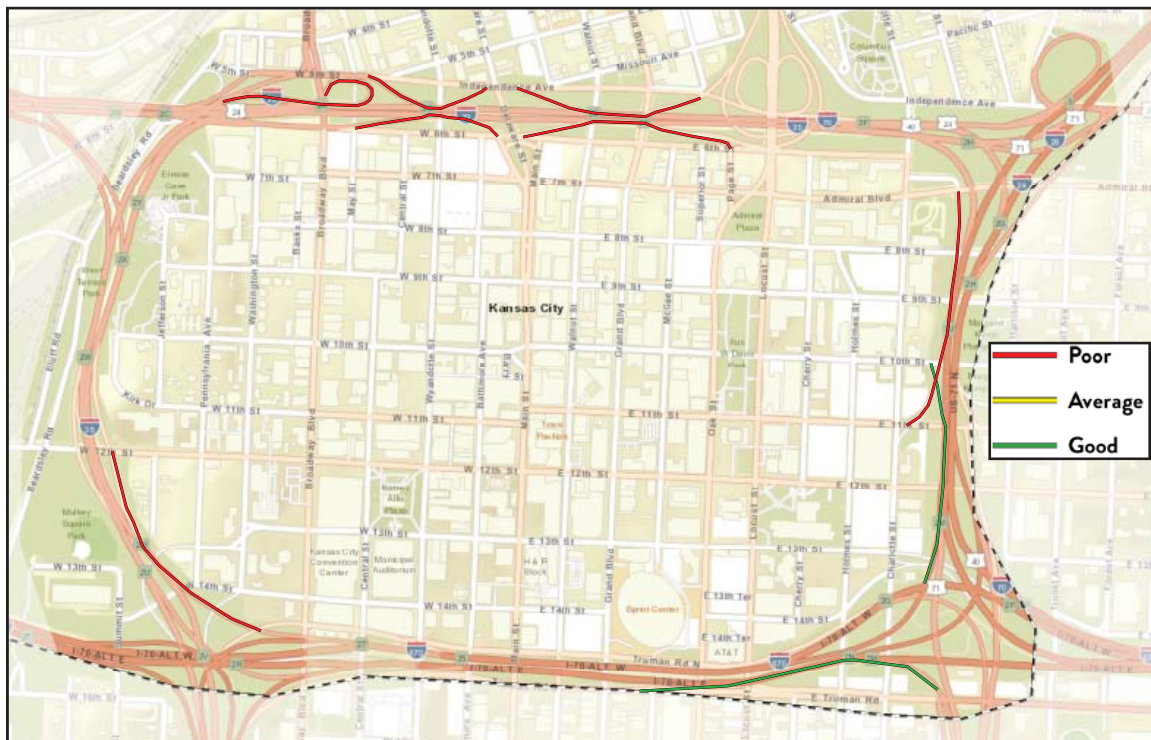
Figure 2.8 - Acceleration and Deceleration Lanes Lengths

- **Acceleration and Deceleration Lanes** — Most of the acceleration and deceleration lanes provided for ramp movements do not meet current design standards for desired length. Additionally, nine locations within the Downtown Loop have a shared-use acceleration/deceleration lane, with seven of the nine locations using a shared lane that is less than a desired minimum of 1600 feet. The short length and shared function of the acceleration and deceleration lanes impacts travel efficiency and adds conflict points for weaving traffic. Figure 2.8 illustrates current acceleration and deceleration lane lengths in comparison to the recommended design length established by AASHTO for ramp movements in the Downtown Loop.
